Discuss the evolution of the given area in Hulme.

Why did the Hulme Crescents fail and was it solely due to its architecture?

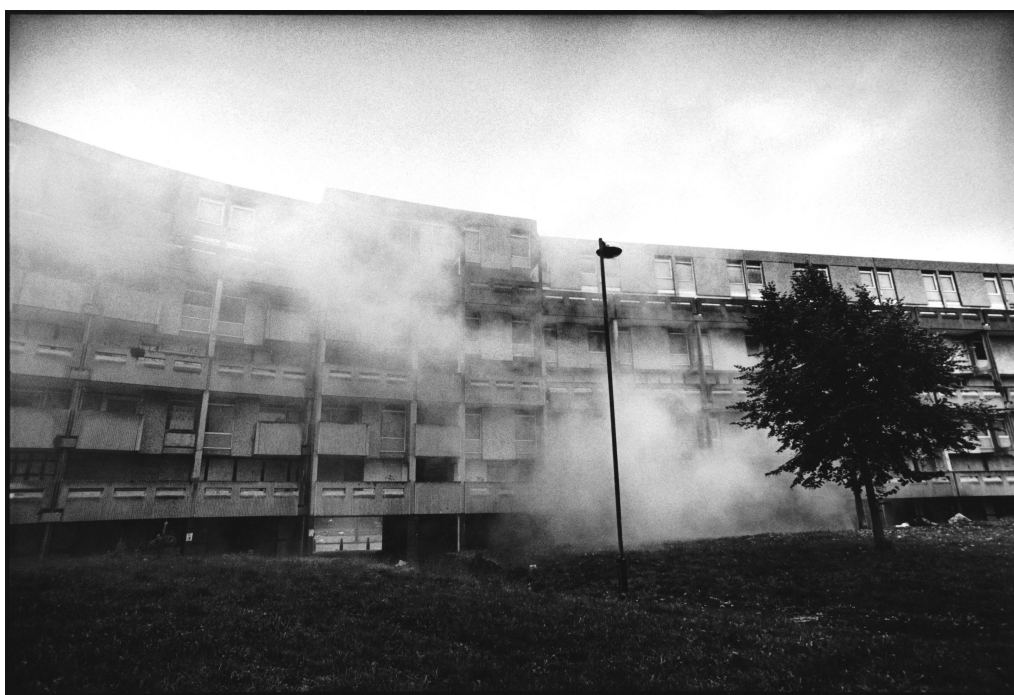
Figure 5: Hulme Crescent in mist (Source: Sacha Lehrfreund, 1991).

Construction on the Hulme Crescents, which had started in 1968, was completed in 1972. Across 38 acres, 918 dwellings were built, using a structural system of both precast and in situ concrete, together with concrete facade panels (The Architectural Review, 1968). The proportions and curved fronts were intended to imitate the elegant Georgian terraces of Bath, but it had the opposite effect. The Crescents were bleak and forbidding, as seen in *Figure 5* (Sacha Lehrfreund, 1991).

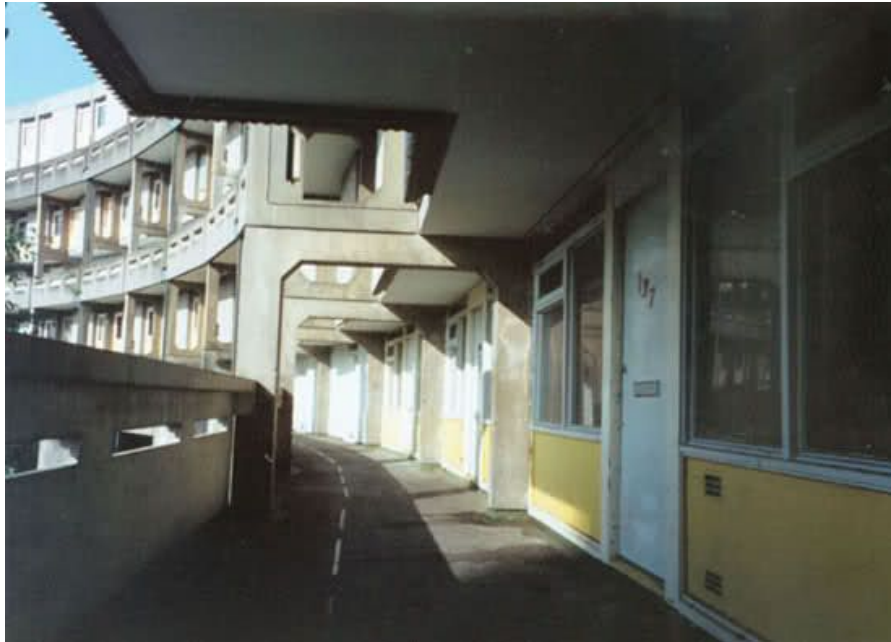
Figure 7: The Crescents' walkways (Source: eXHuLMe, no date:online).

Not only did construction problems start to show upon finish, but within months design problems became obvious. The social impact of the concept of 'streets in the sky' had not been thoroughly researched, and the Crescents soon became a social disaster. The design of the estate focused on pedestrian priority; the main shopping street had been removed altogether, thus isolating residents and destroying their link with the city (Hartwell, 2002). This was reinforced by the large main roads that encased the estate. Additionally, the authorities' distrust of the community was immediately apparent. For example, the youth centre was enclosed by a twelve-foot-high fence and alarmed (Conn, 1973), resulting in the community becoming similarly distrustful of the authorities. Within the buildings themselves, the walkways were a no-man's land, encouraging anti-social behaviour. They can be seen in *Figure 7* (eXHULMe, no date:online). Due to their elevated distance from any roads, the police did not patrol them as they would normal streets (Granada TV, 1978). This fact and their hidden visibility from below meant robberies could be carried out completely unnoticed. The walkways became perfect mugging territory; it was easy to corner people and assailants could easily escape by bicycle. Vandalism was abundant. Milk and newspaper deliveries ceased. Many residents, especially women and the elderly, refrained from leaving their homes (Parkinson-Bailey, 2000). The noise levels of children playing on the decks,

amplified by inadequate acoustic insulation, irritated residents and contributed to their stress (Granada TV, 1978). There was a decline in the mental health of residents, with high levels of loneliness, anxiety and depression (Parkinson-Bailey, 2000). The impersonal bleakness of the design, with the dark and gloomy walkways, added to people's unhappiness.

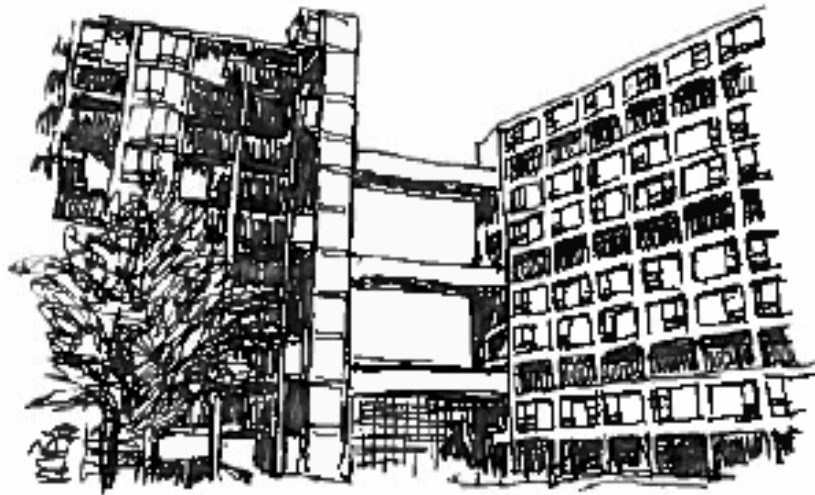
Figure 8: Park Hill estate in Sheffield.

discussed), but there were also other factors. Poor construction, due to the Government pressure on Manchester Corporation for fast-built homes, also played an important role. In fact, it could be argued that the Crescents' would still exist today if not for its hasty construction. Park Hill in Sheffield (shown in *Figure 8*), designed very similarly and by the same architect J. Lewis Womersley, still exists today (Parkinson-Bailey, 2000). The estate had various social problems, as did the Crescents, but it has always been structurally sound (The Concrete Company, no date).
